# Manhole Inspection Summary

Manhole # S35G\_\_026MH

Insp Date: **3/25/09 9:32 AM**

**Location** Address: **6 E BALTIMORE ST**

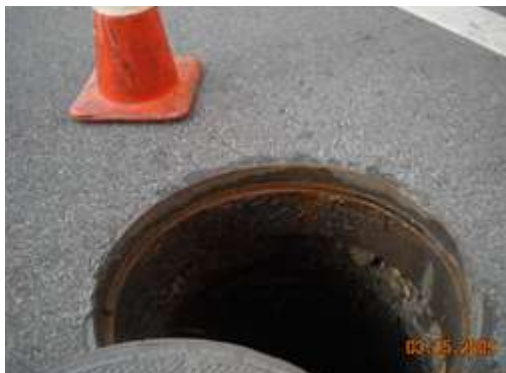
MISC.

**Manhole** Type: **Inline** Location: **Roadway** Ground Conditions: **Dry**  
☐ Prev. Rehab Weather: **Dry** Subject To Ponding: **Sheeting**  
Comments **TRAFFIC CONTROL, LANE CLOSED; USED 16LB MAUL AND SPRAY LUBRICANT TO FORCE OPEN COVER;**

INFLOW EVIDENCE FROM SHEETING

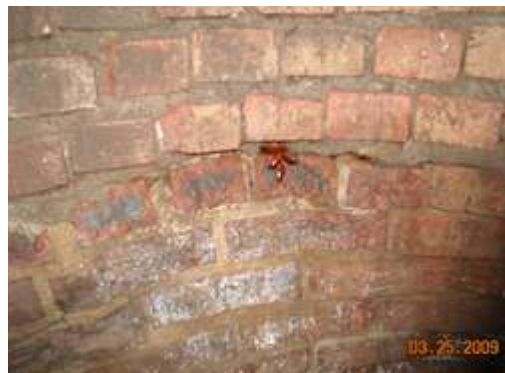
Defect 3

**Barrel** Material: **Brick** ☐ Parged  
Shape: **Rectangular** Diameter: **48** (in.) Length: **42** (in.)  
Condition: ☐ Sound ☐ Cracked ☐ Root Intrusion ☐ Loose Brick ☒ **Deteriorated**  
Infiltration: ☒ None ☐ Joint ☐ Cracks ☐ Mortar ☐ Roots ☐ Wall

DETERIORATED BARREL BRICK FACES, WHERE ROACHES HAVE GATHERED

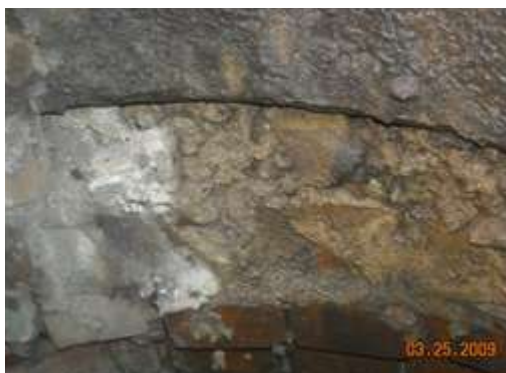
Defect 2

**Frame** Offset: **2** (in.) Condition: ☐ Sound ☐ Cracked ☒ **Leaks**

**Chimney / Frame Adjustment** ☒ Exists Material: **Brick and Concrete** ☐ Parged Height: **6** (in.)  
Condition: ☐ Sound ☐ Cracked ☐ Root Intrusion ☐ Loose Brick ☒ **Deteriorated**  
Infiltration: ☐ None ☒ **Joint** ☐ Cracks ☐ Mortar ☐ Roots ☐ Wall

DETERIORATED CHIMNEY, FRAME LEAKS, CHIMNEY INFILTRATION

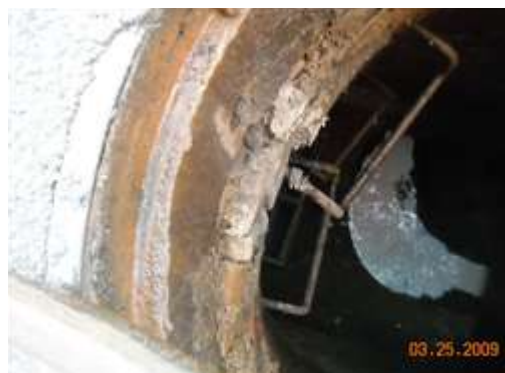
Defect 1

FRAME OFFSET

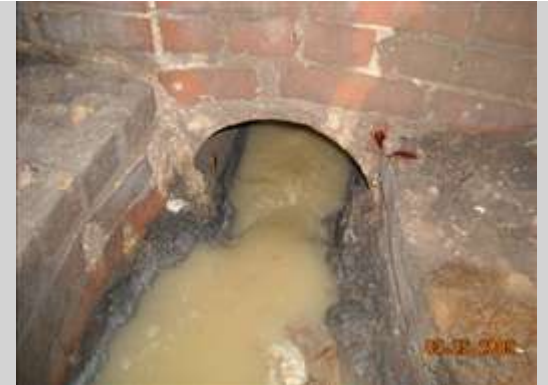
12 O'Clock Outflow

12 in. Circular Gravity Sewer  
Pipe Out @ 12 O'Clock

Pipe Height: **12** (in.) Rod and Bar (Angled)  
Pipe Material: **Clay** ☐ Pipe Lined  
Invert Depth: **10.00** (ft.) Flow Characteristics: **Fast**  
Deposits: ☒ None ☐ Mud ☐ Sludge ☐ Debris ☐ Grease  
Silt Depth: **0** (in.) Deposits Extent:  
Infiltration: **None** Pipe Seal Cond: **Sound**

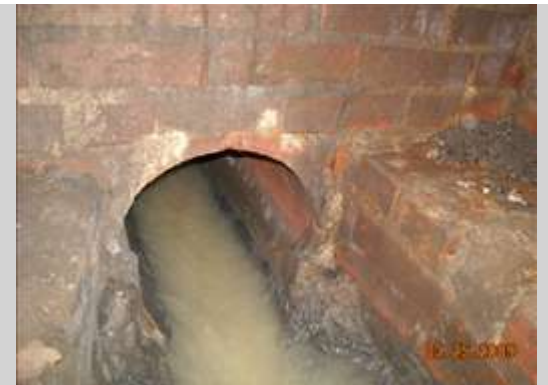
3 O'Clock Inflow

12 in. Circular Gravity Sewer  
Pipe In @ 3 O'Clock

Pipe Height: **12** (in.) Rod and Bar (Angled)  
Pipe Material: **Clay** ☐ Pipe Lined  
Invert Depth: **9.75** (ft.) Flow Characteristics: **Fast**  
Deposits: ☒ None ☐ Mud ☐ Sludge ☐ Debris ☐ Grease  
Silt Depth: **0** (in.) Deposits Extent:  
Infiltration: **None** Pipe Seal Cond: **Sound**
